ASSESSMENT OF CORAL DAMAGE CAUSED BY A GROUNDED BARGE ON TANAPAG BARRIER REEF, SAIPAN, CNMI

ENVIRONMENTAL SURVEY REPORT

No. 20

April, 1987

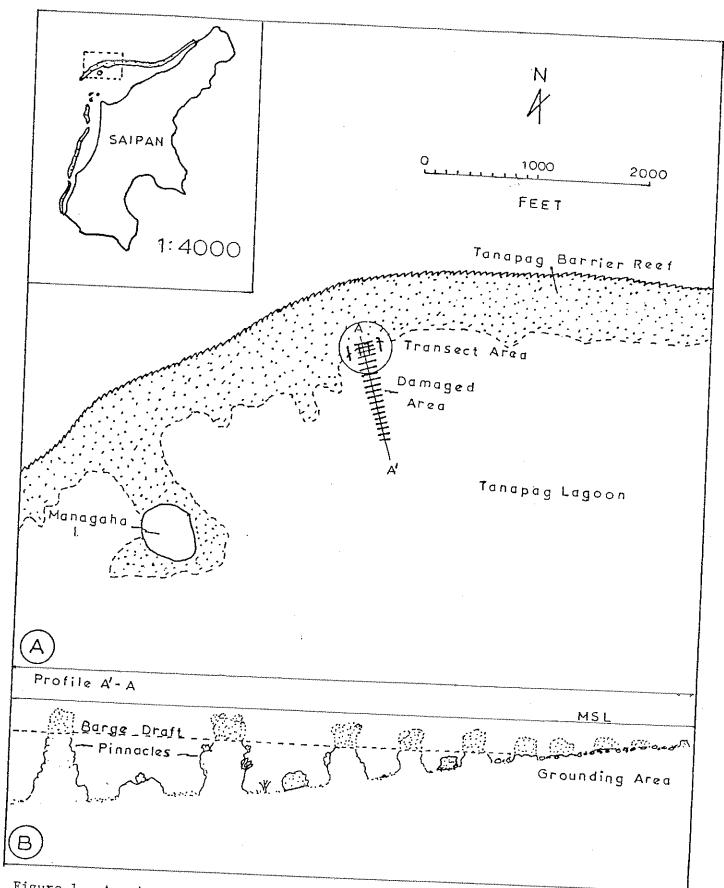
Based upon reconnaissance snorkel observations it appears that as the barge drifted out of deeper regions of Tanapag Lagoon into shoaler water it began to make contact with some of the more prominent topographic relief features, such as coral mounds, pinnacles, and knobs. As the barge drifted into even shoaler lagoon areas more bottom contacts were made, which included overturning and disintegration of coral knobs and pinnacles. Continued drift carried the barge to the shallow lagoonward edge of the barrier reef where the bottom shoals rapidly to the shallow barrier reef-flat platform. At this location the barge became somewhat solidly grounded, but with some vertical and lateral motion in response to storm surge. Within this grounded area most topographic relief features were disintegrated with a resultant maximum relief of mostly less than 30 cm. adjacent undamaged reef areas topographic relief features with up to 2 meters of relief were common to abundant. Other evidence for recent disintegration of insitu framework reef deposits included an abundance of angular sand-to bouldersize fragments veneering the surface. Within the undamaged area such fragment were much less abundant and instead of being angular were worn and subrounded.

Figure 1. A - Assessment area showing the transect and damaged reef areas. Stippled area denotes the shallow barrier reef platform. B - Vertical profile through the damaged reef area. Stippling denotes damaged coral pinnacles caused by the drifting barge.
